The Mumma Barn

# ANTIETAM

# Historic Structure Report

April 2000

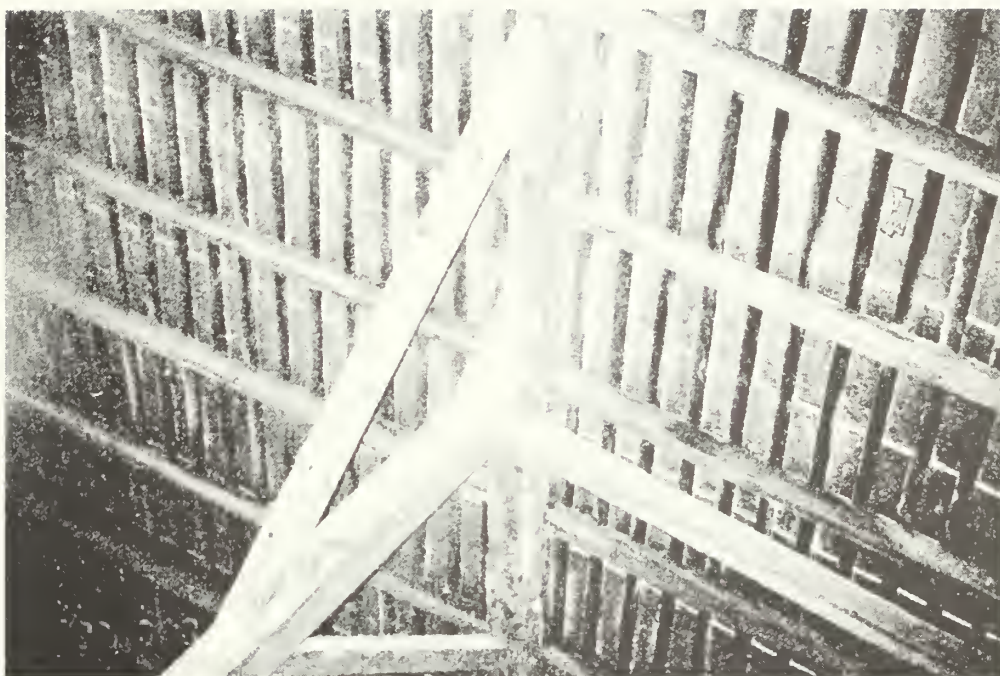
Figure 84: Rotted connection of angled purlin post (diagonal brace) to roof purlin (forebay side of interior).

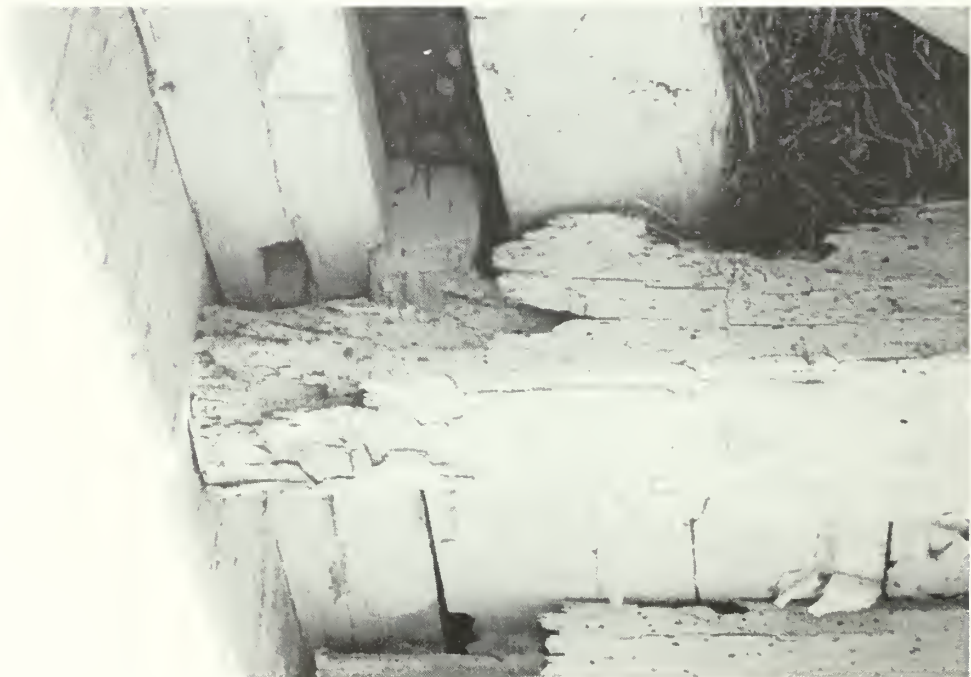
Figure 91: Detail of deteriorated joist ends.

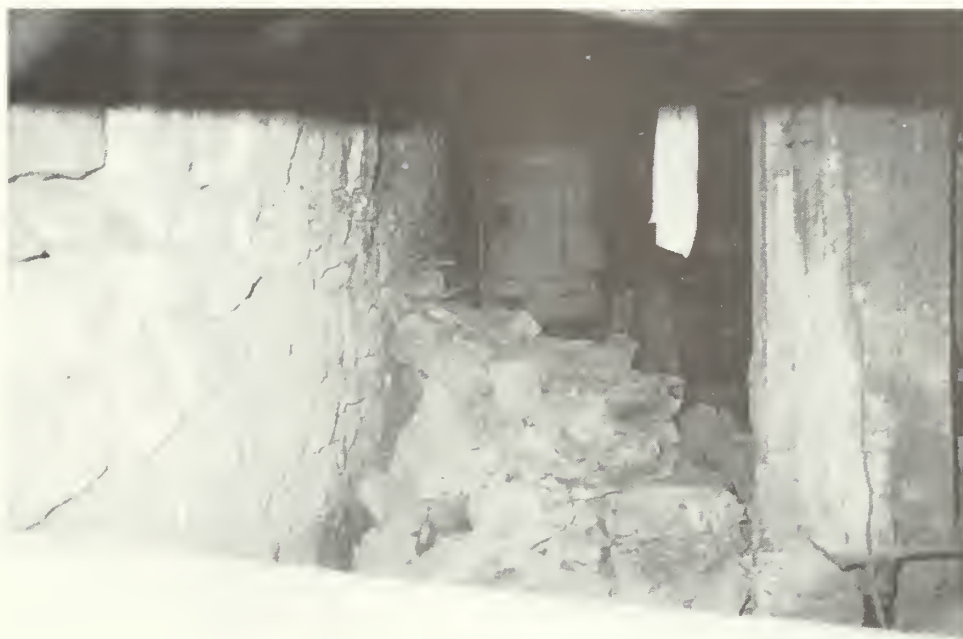
Figure 96: Collapsed northwest foundation wall. The wall came down in September of 1997 and was rebuilt in December of 1997.

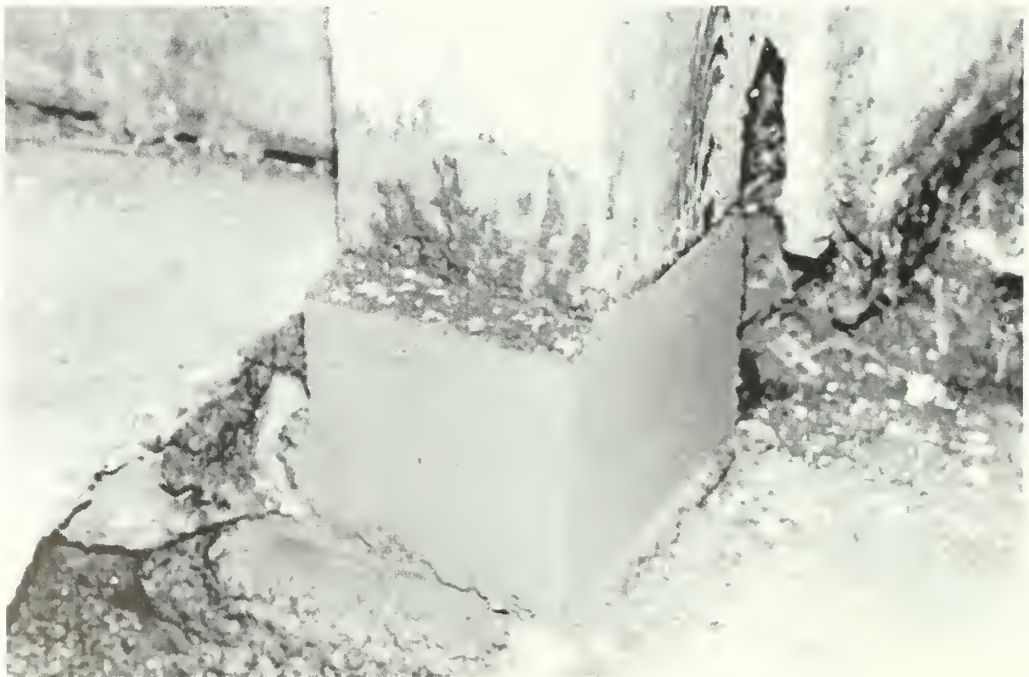
Figure 106: Repair of post where base had rotted away (repair completed by park in 1985).

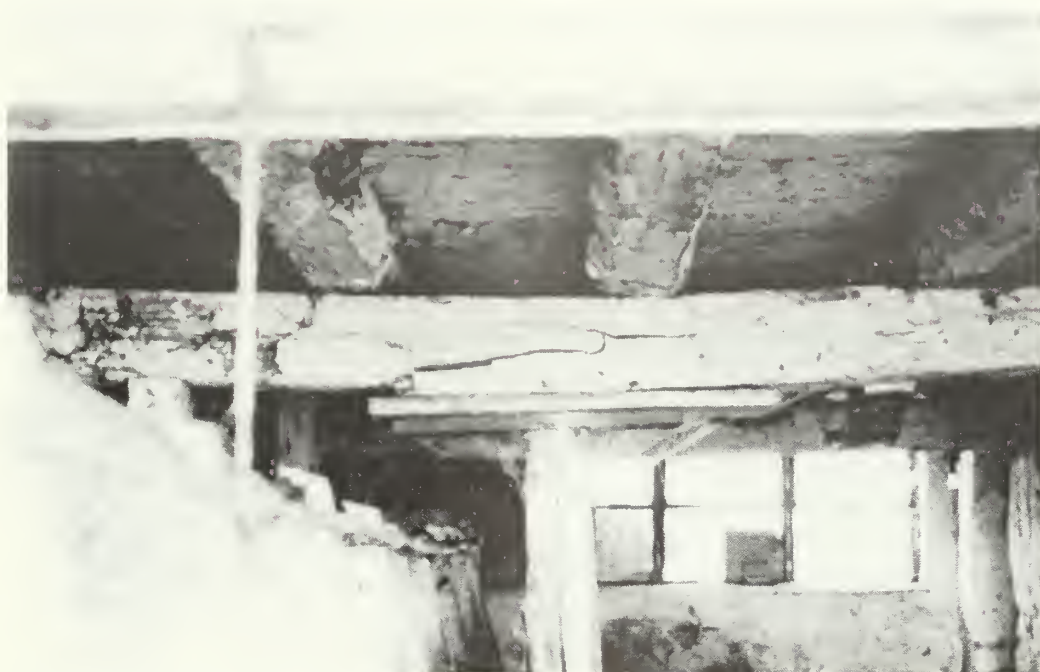
Figure 108: Failed girder on northeast side of barn prior to repair (1985).

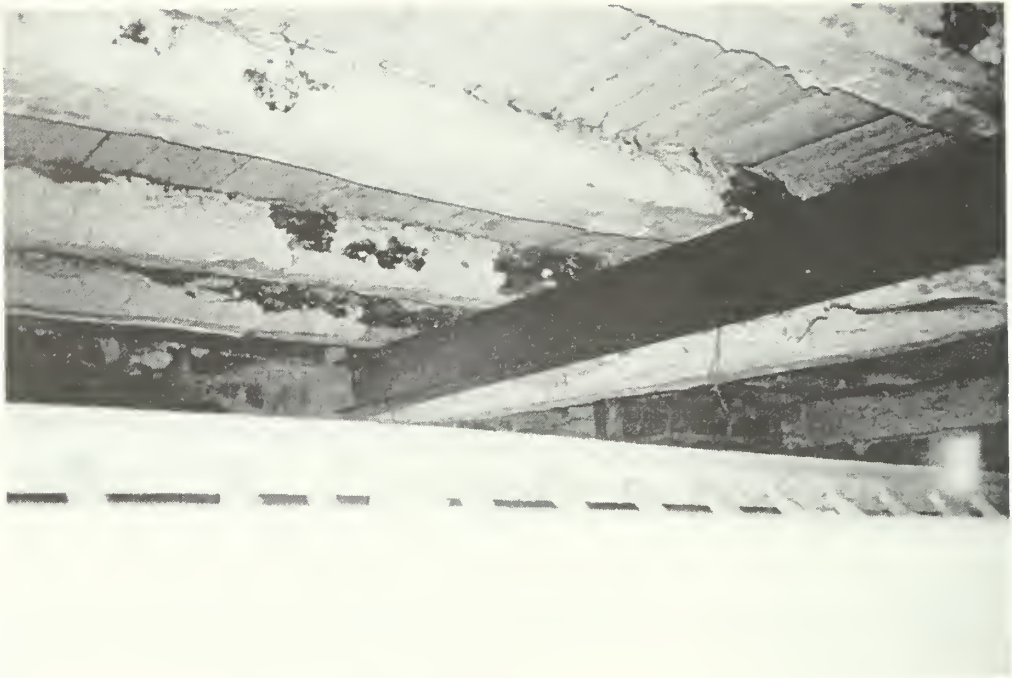
Figure 109: Steel beam in place to temporarily correct failed girder.

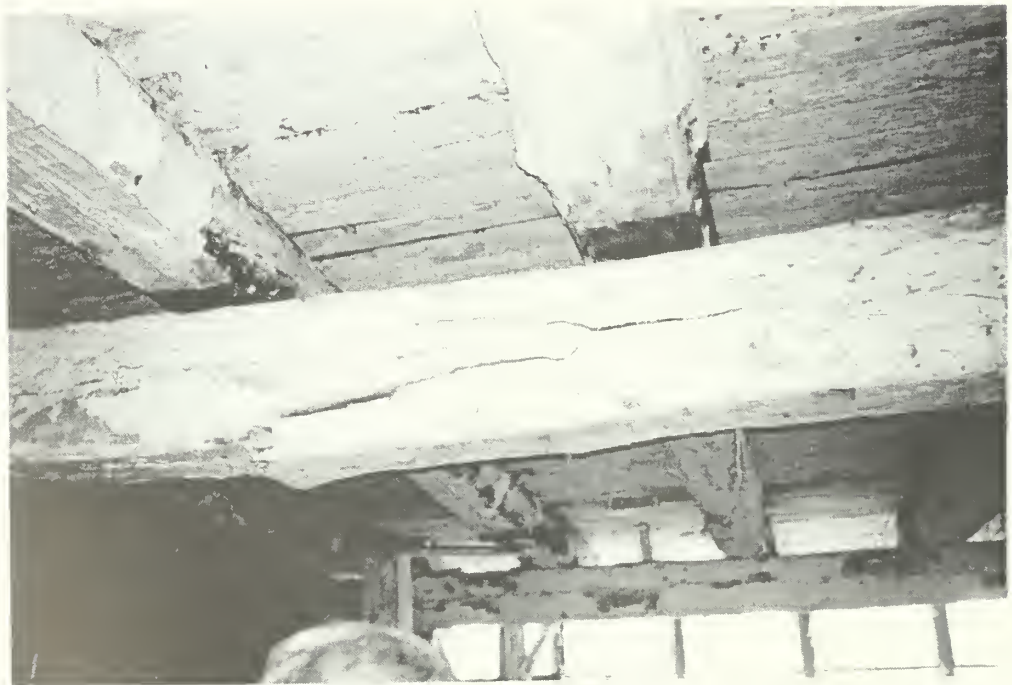
Figure 110: Damage still evident on the opposite side of the girder from the steel beam.

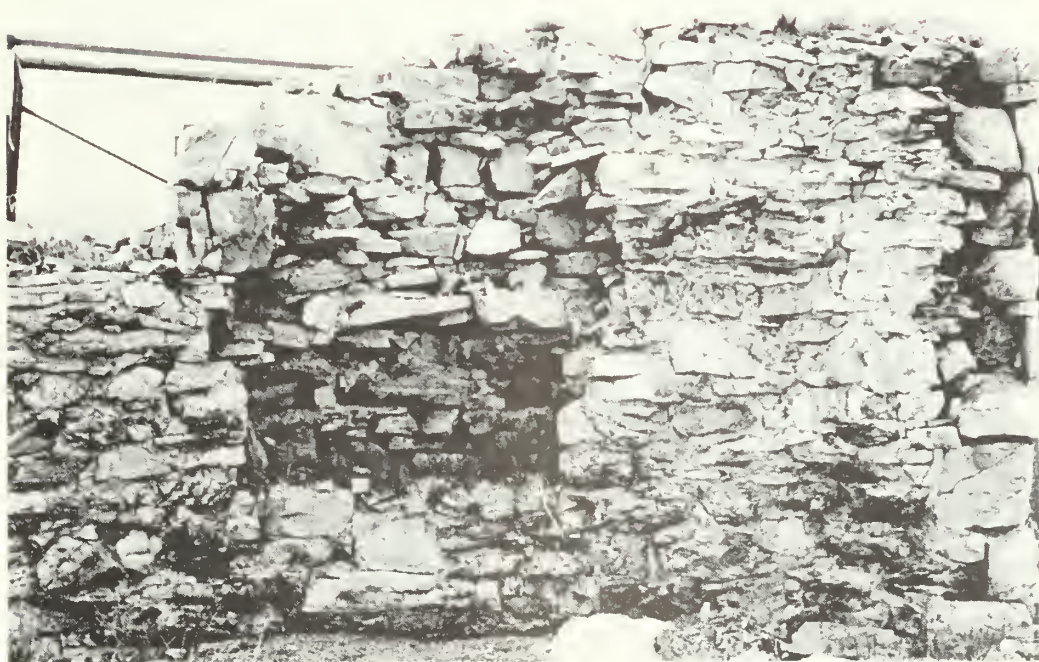
Figure 112: Condition of ruined Sherrick Barn foundation prior to stabilization.

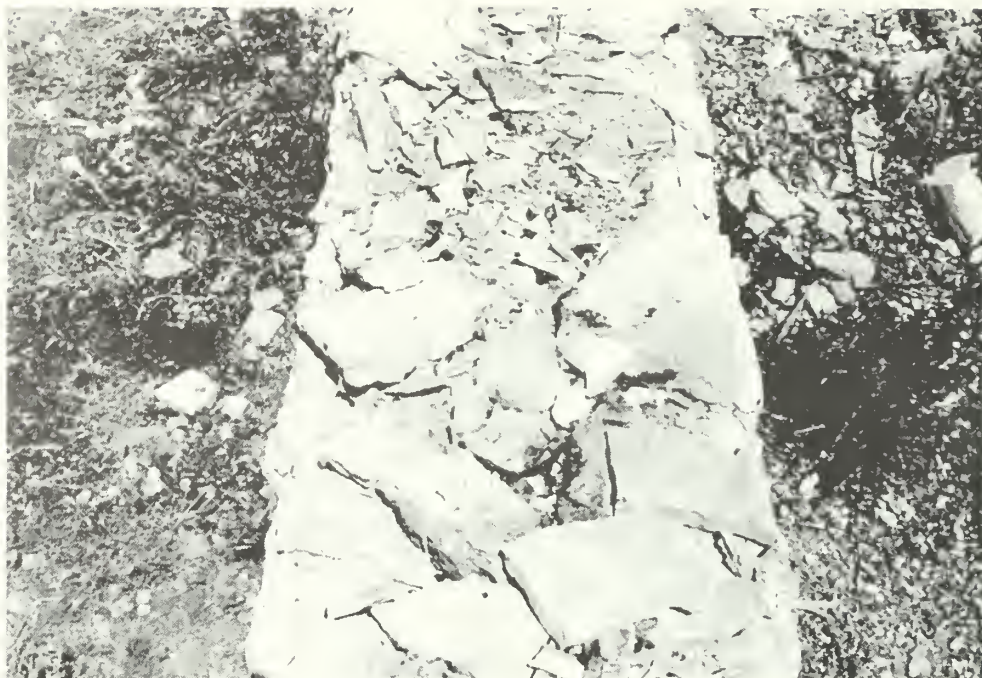
Figure 113: Condition of ruined Sherrick Barn foundation prior to stabilization. Note failure of limestone when exposed to extreme heat.

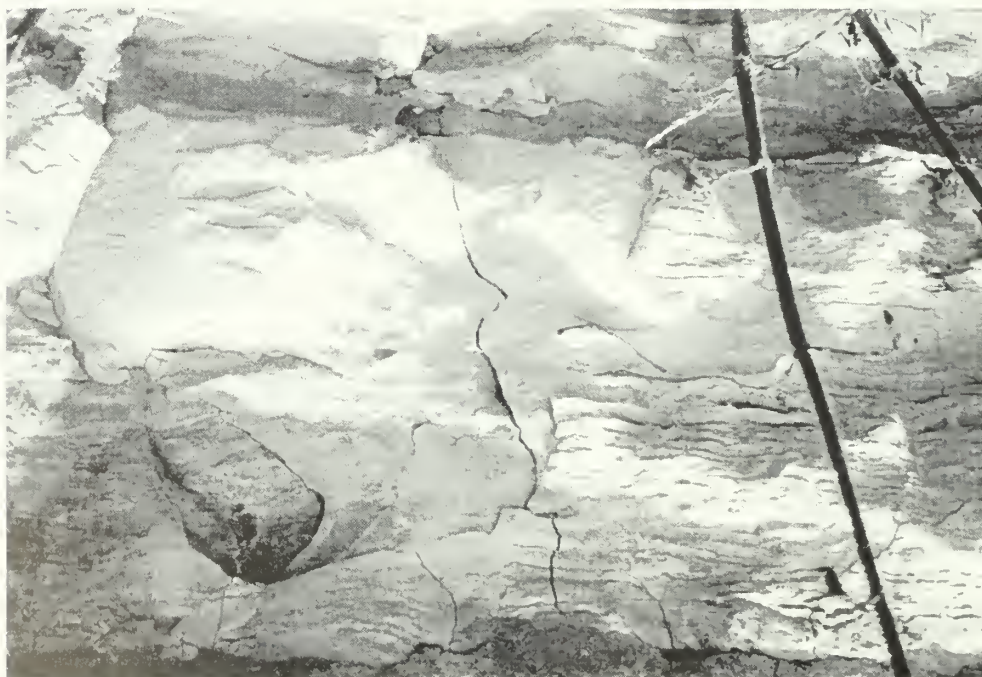
Figure 114: Fracture of limestone foundation of the ruined Sherrick Barn due to extreme heat.

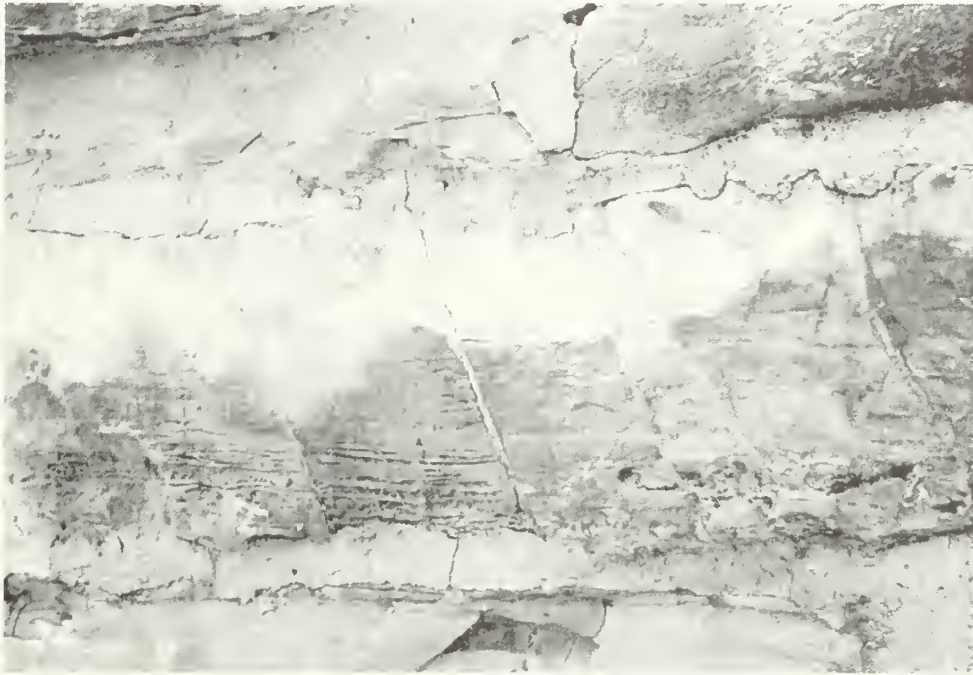
Figure 115: Red color of limestone caused by excessive heat.

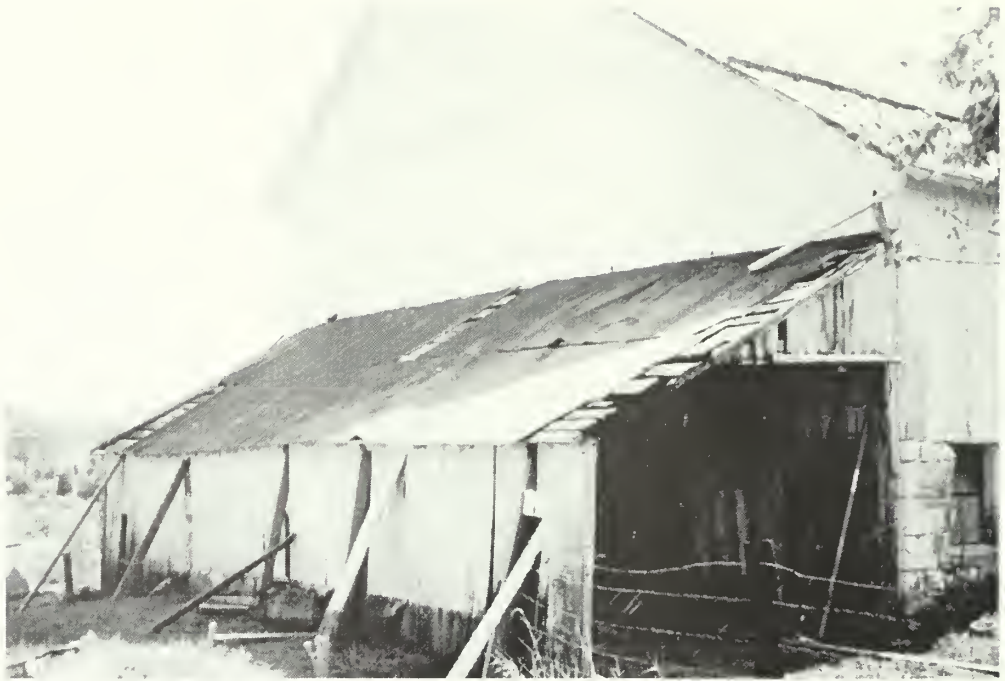
Figure 123: Condition of implement shed in 1990, prior to stabilization (from the north).

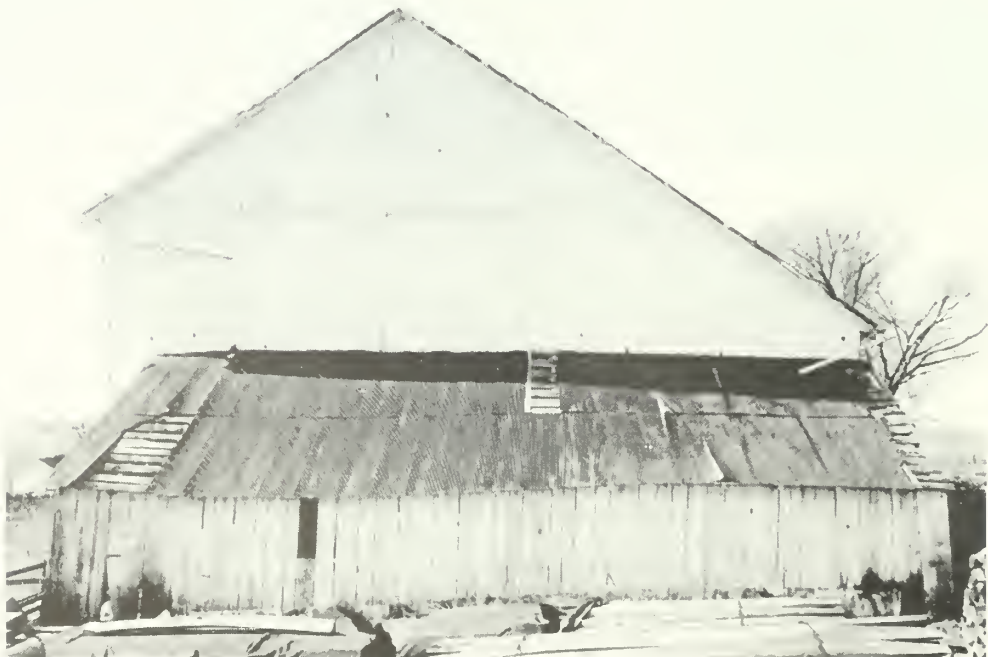
Figure 124: condition of implement shed in 1990, prior to stabilization (from the northeast).

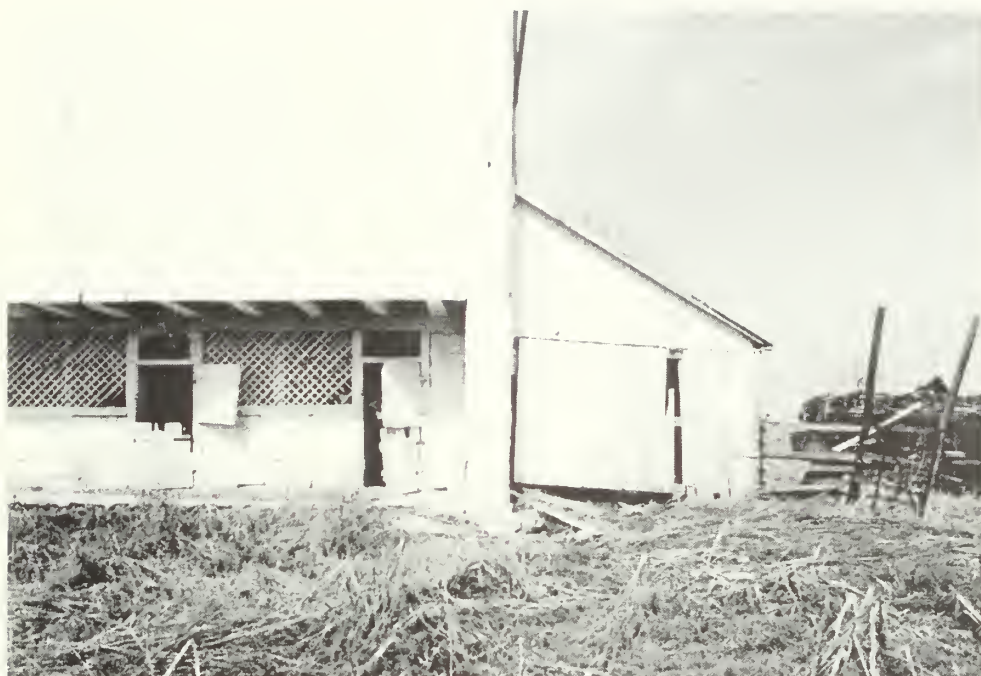
Figure 125: condition of implement shed in 1990, prior to stabilization (from the southeast).

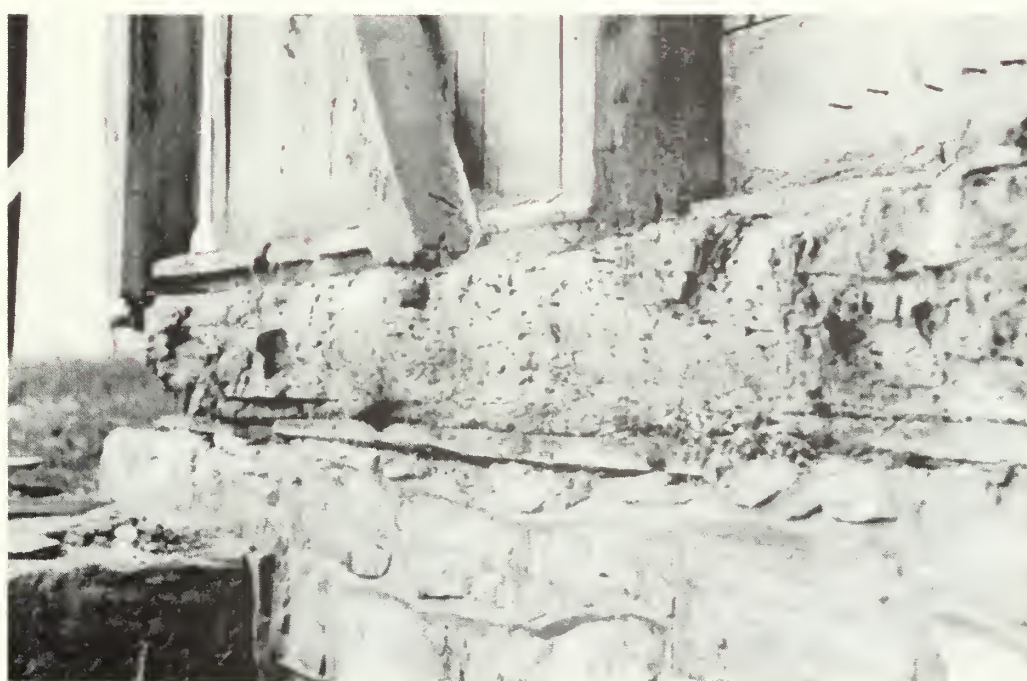
Figure 130: Condition of exterior of northwest granary during 1992 repair work by park maintenance crew. Note deteriorated condition of sill due to insect attack and moisture damage.

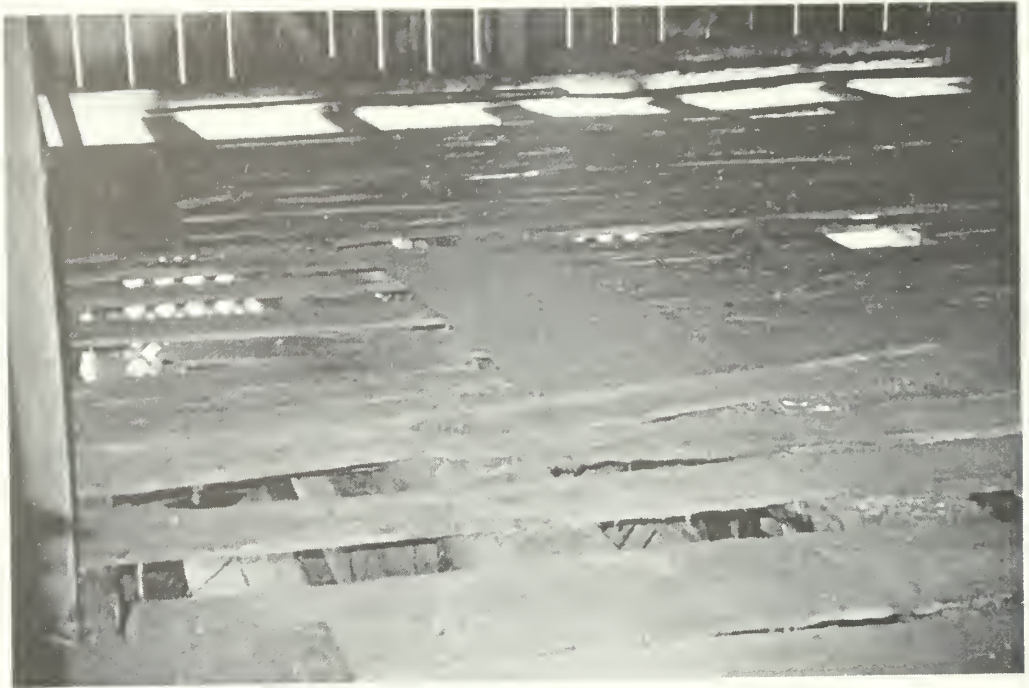
Figure 148: Original, wood threshing floor. Damaged area of the floor was patched with galvanized metal.

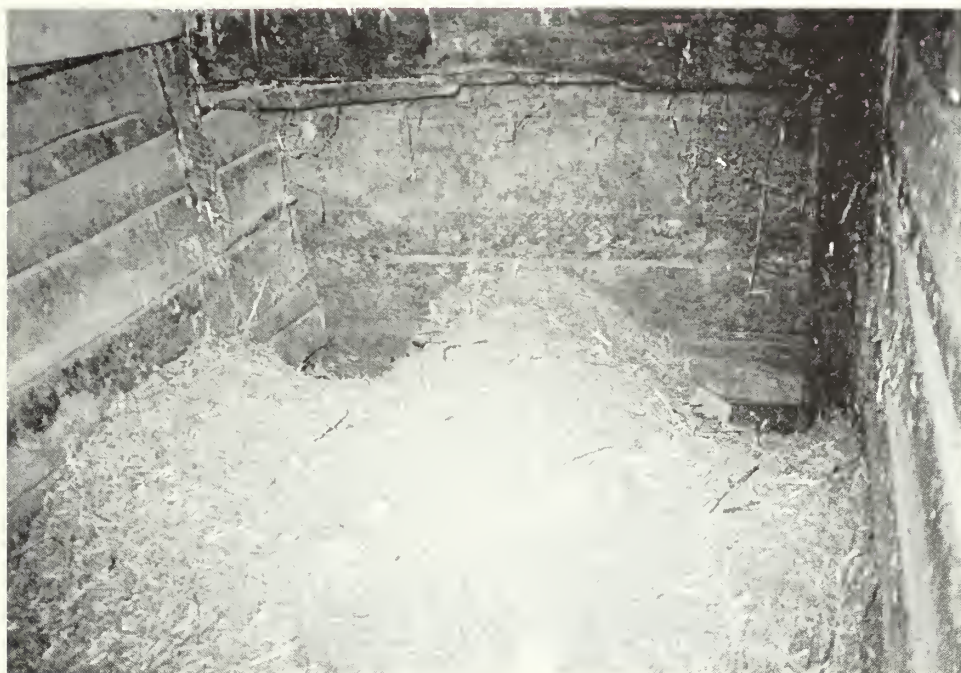
Figure 156: Evidence of rodent infestation.

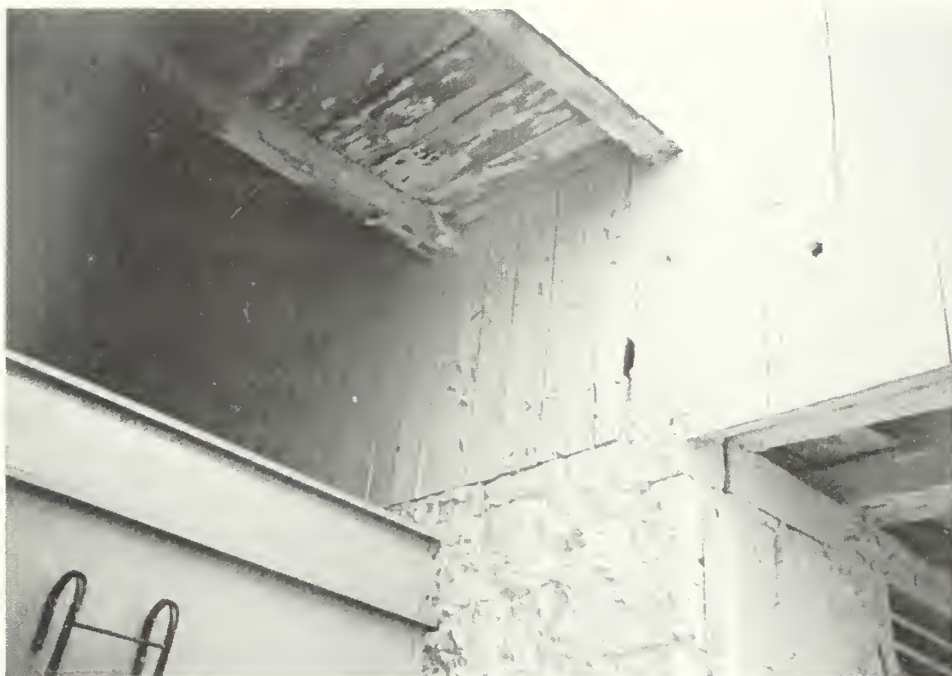
Figure 171: Damaged siding at south end of wagon shed.

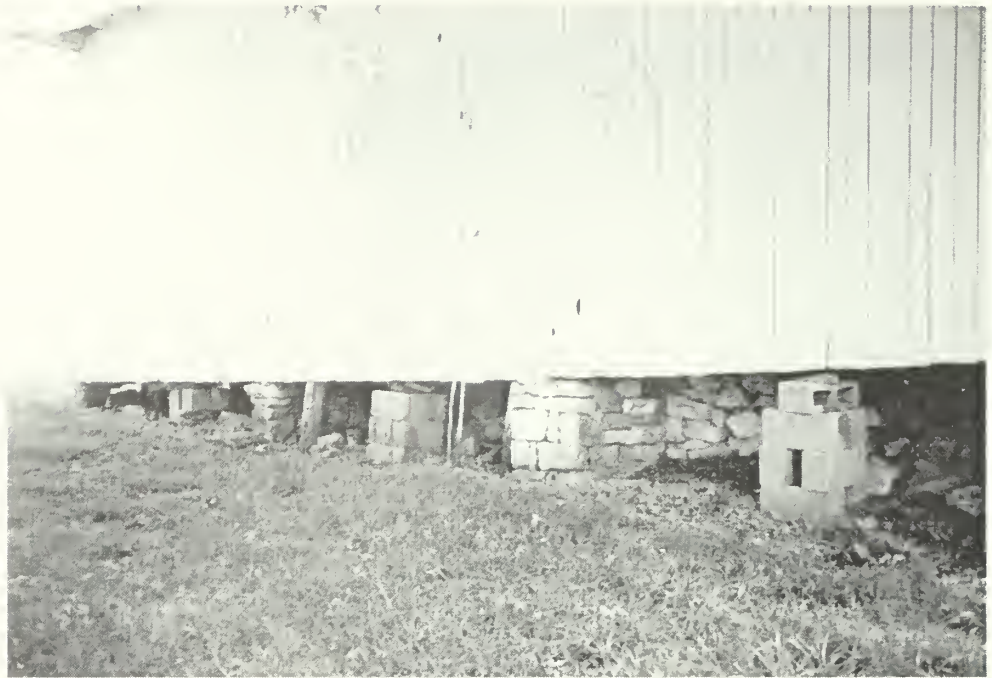
Figure 173: Exterior of corn crib (southwest elevation). Note deteriorated state of foundation.

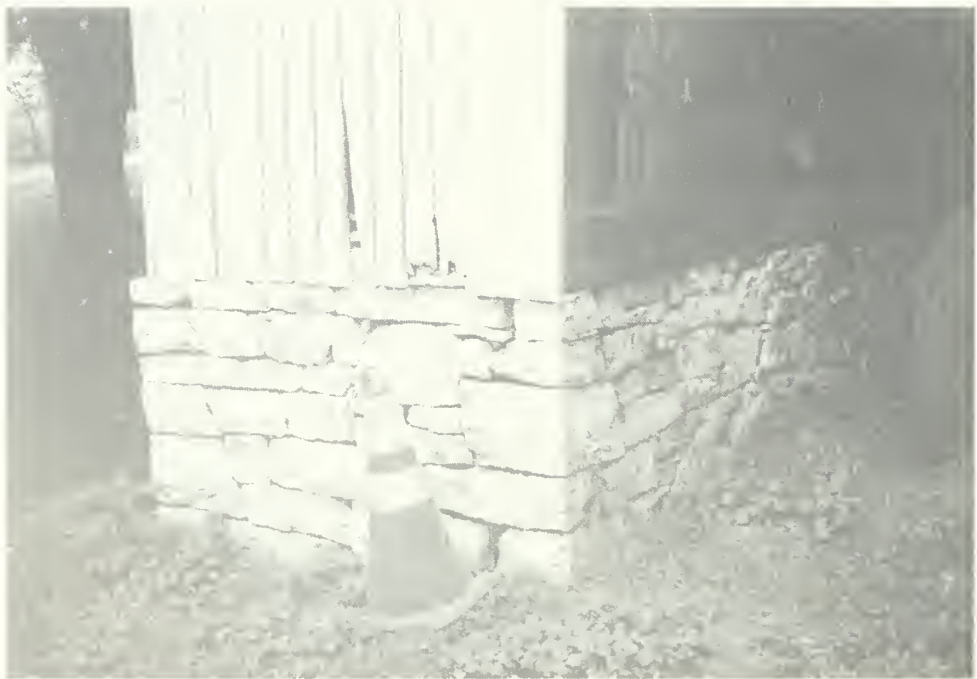
Figure 174: Deteriorated foundation wall of corn crib (southeast elevation).

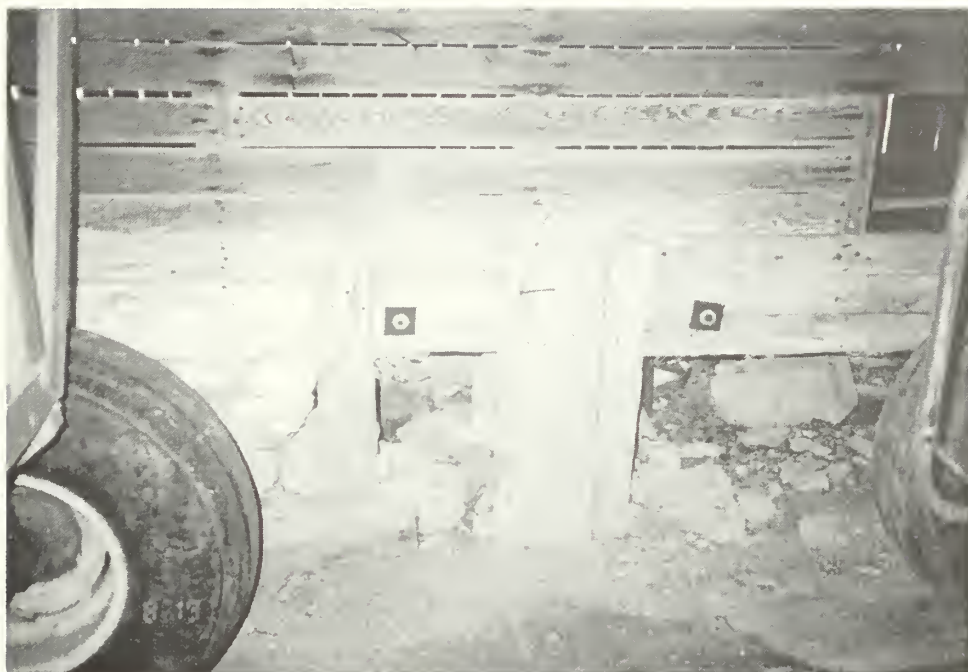
Figure 175: Deteriorated siding and foundation of shared wall between corn crib and wagon shed.

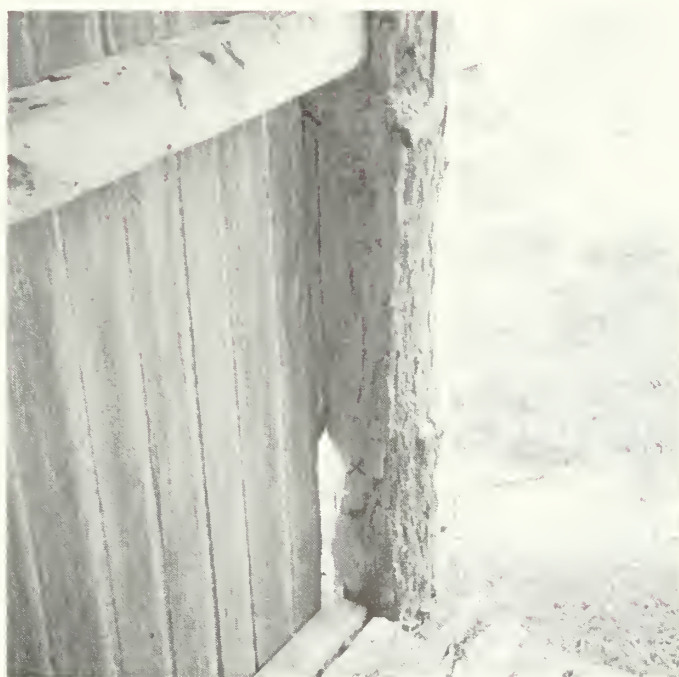
Figure 176: Post at front of corn crib damaged by insect attack.

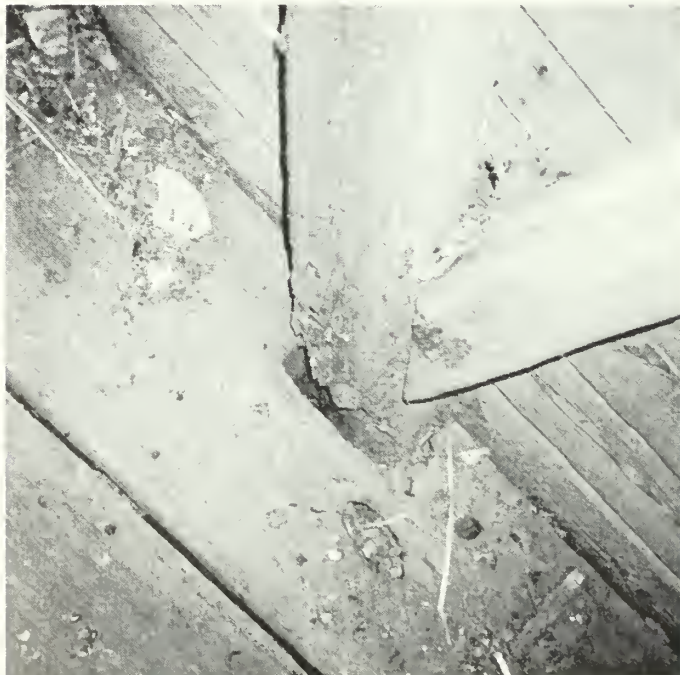
Figure 178: Deterioration where vertical post and diagonal brace meet floor (at interior of corn crib).

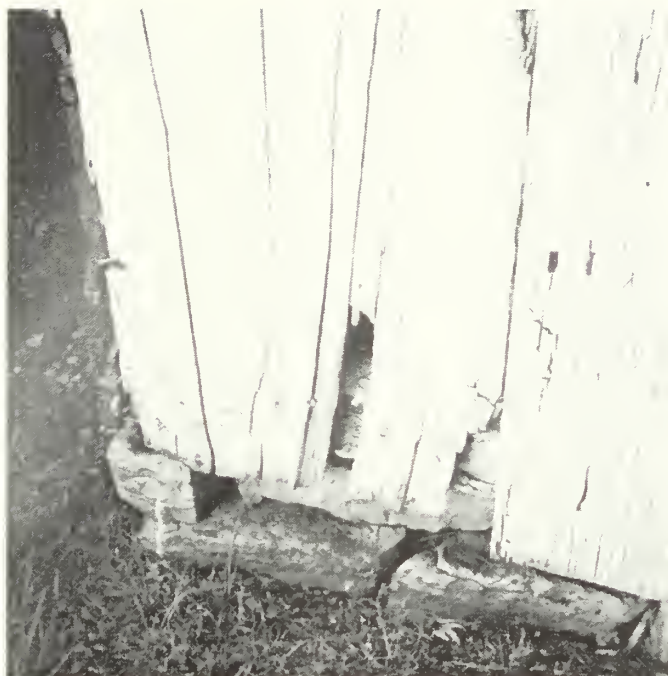
Figure 179: Damaged siding at exterior of corn crib.

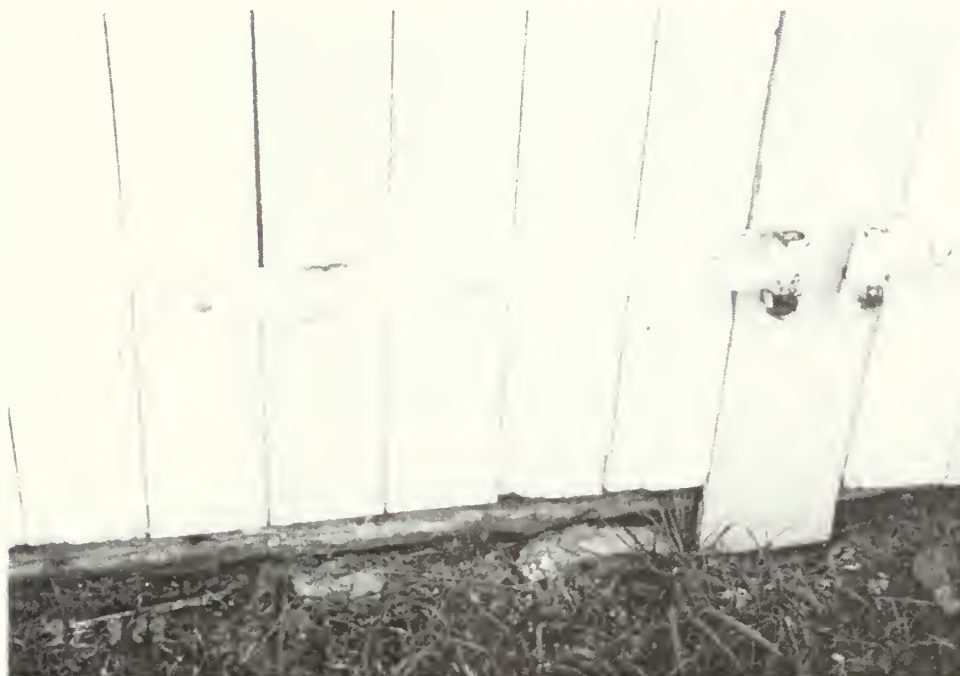
Figure 190: Wood frame of the double doors (southeast elevation). Note insect damage and splintering.

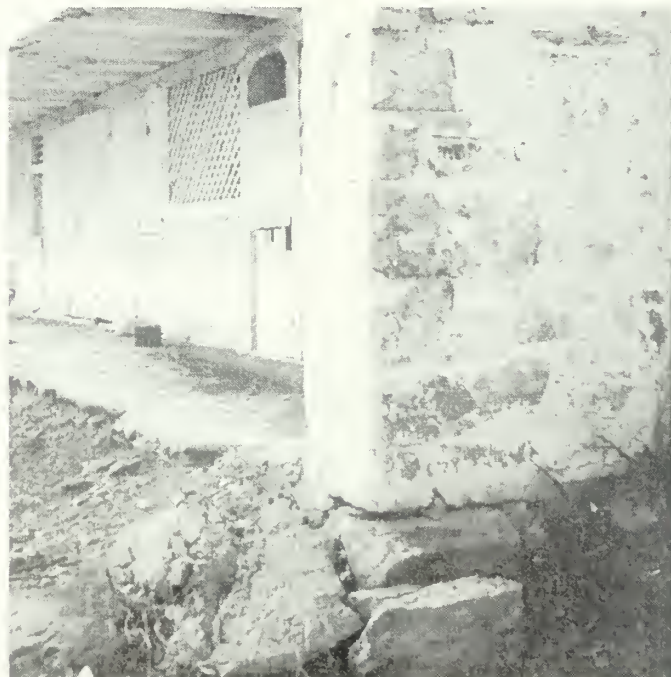
Figure 198: Moisture damage at east corner of barn due to faulty drainage.

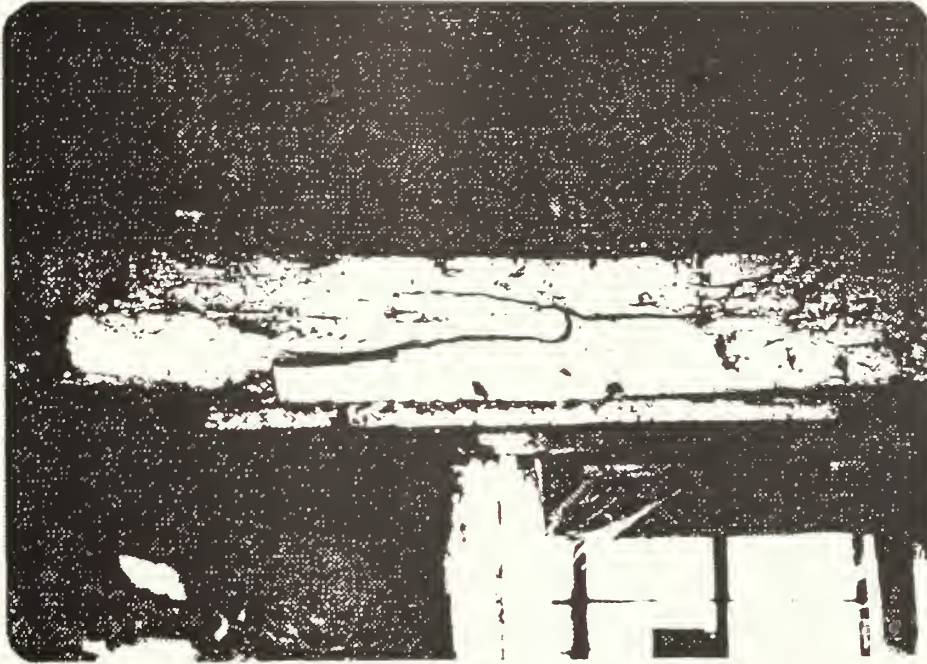
Bldg. 43 - Barn Mumma Farm  
Item 1 - Broken girder - small vertical  
post added for support

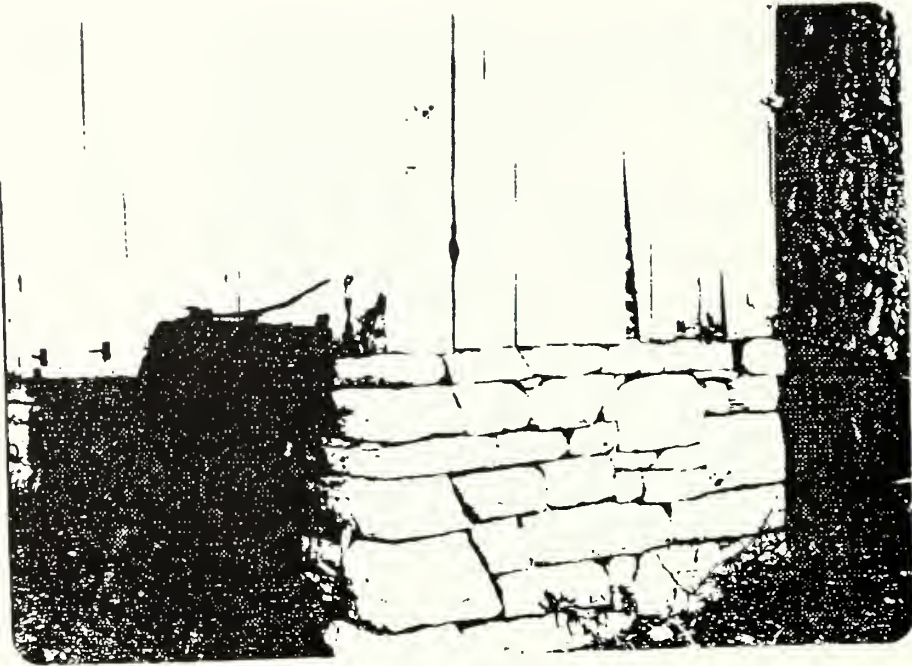
Bldg. 43 - Mumma Farm  
Item 7 - Corn crib footer deterioration

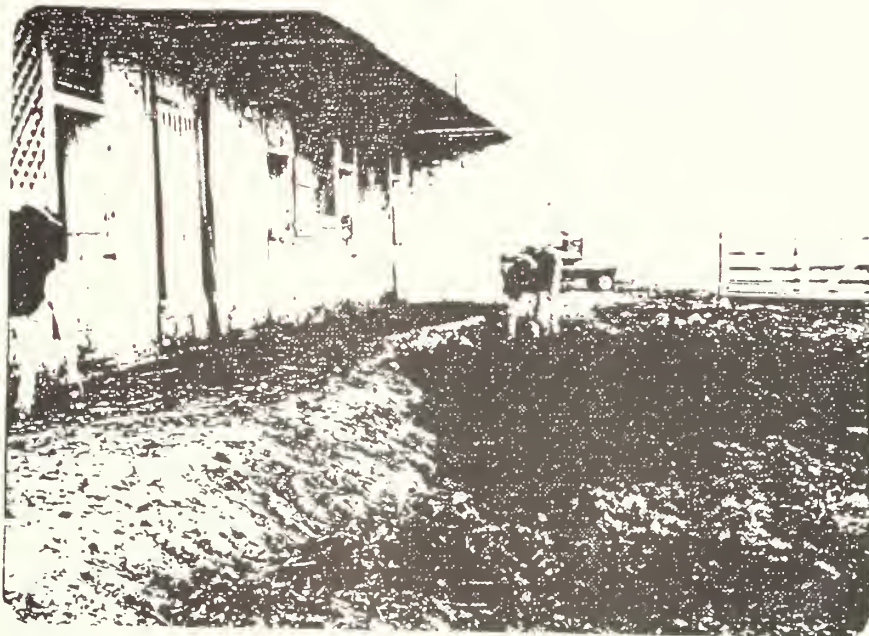
Bldg. 43 - Mumma Barnyard  
Item - Deterioration of yard from  
concrete walkway
